Missouri La Forge  
Farms Project  
Unit 32

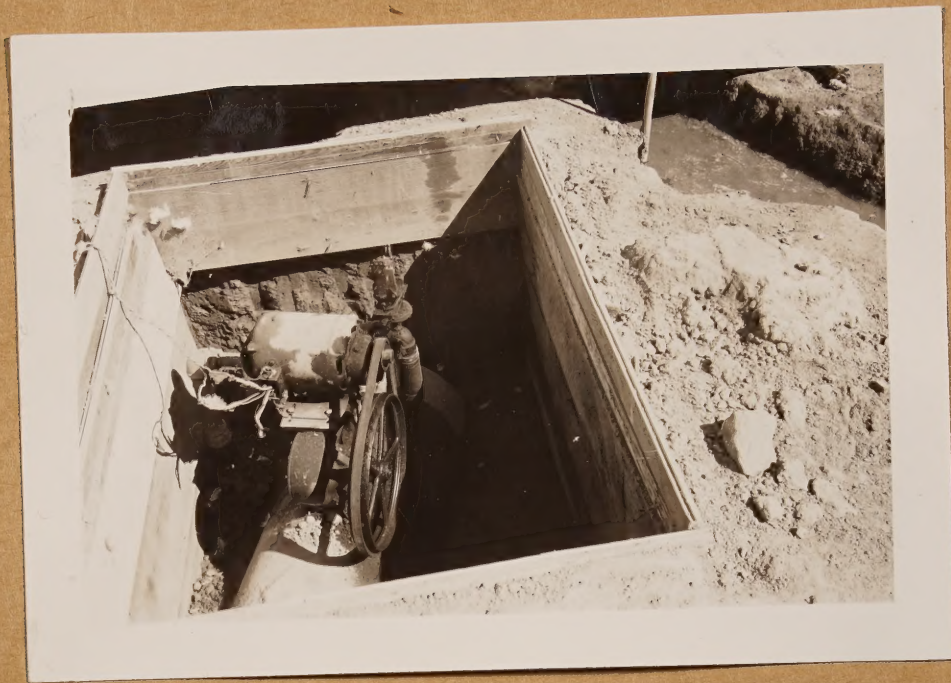
Closeup of an improper installation of a water system. Gate lamp cord to motor, in adequate protection; waste water in open ditch. Moving parts of switch have become so coated with dirt & oil that it sometimes fails to operate automatically.
